Subject: Supplemental Submission for Baxter Road and Sconset Bluff Storm
Damage Prevention Project (DEP File No. SE 048-2581)

**BAXTER ROAD AND SCONSET BLUFF STORM DAMAGE PREVENTION PROJECT
NOTICE OF INTENT (DEP FILE NO. SE 048-2581)**

**RESPONSES TO QUESTIONS FROM NANTUCKET CONSERVATION COMMISSION ASKED AT
PUBLIC HEARING ON AUGUST 28, 2013**

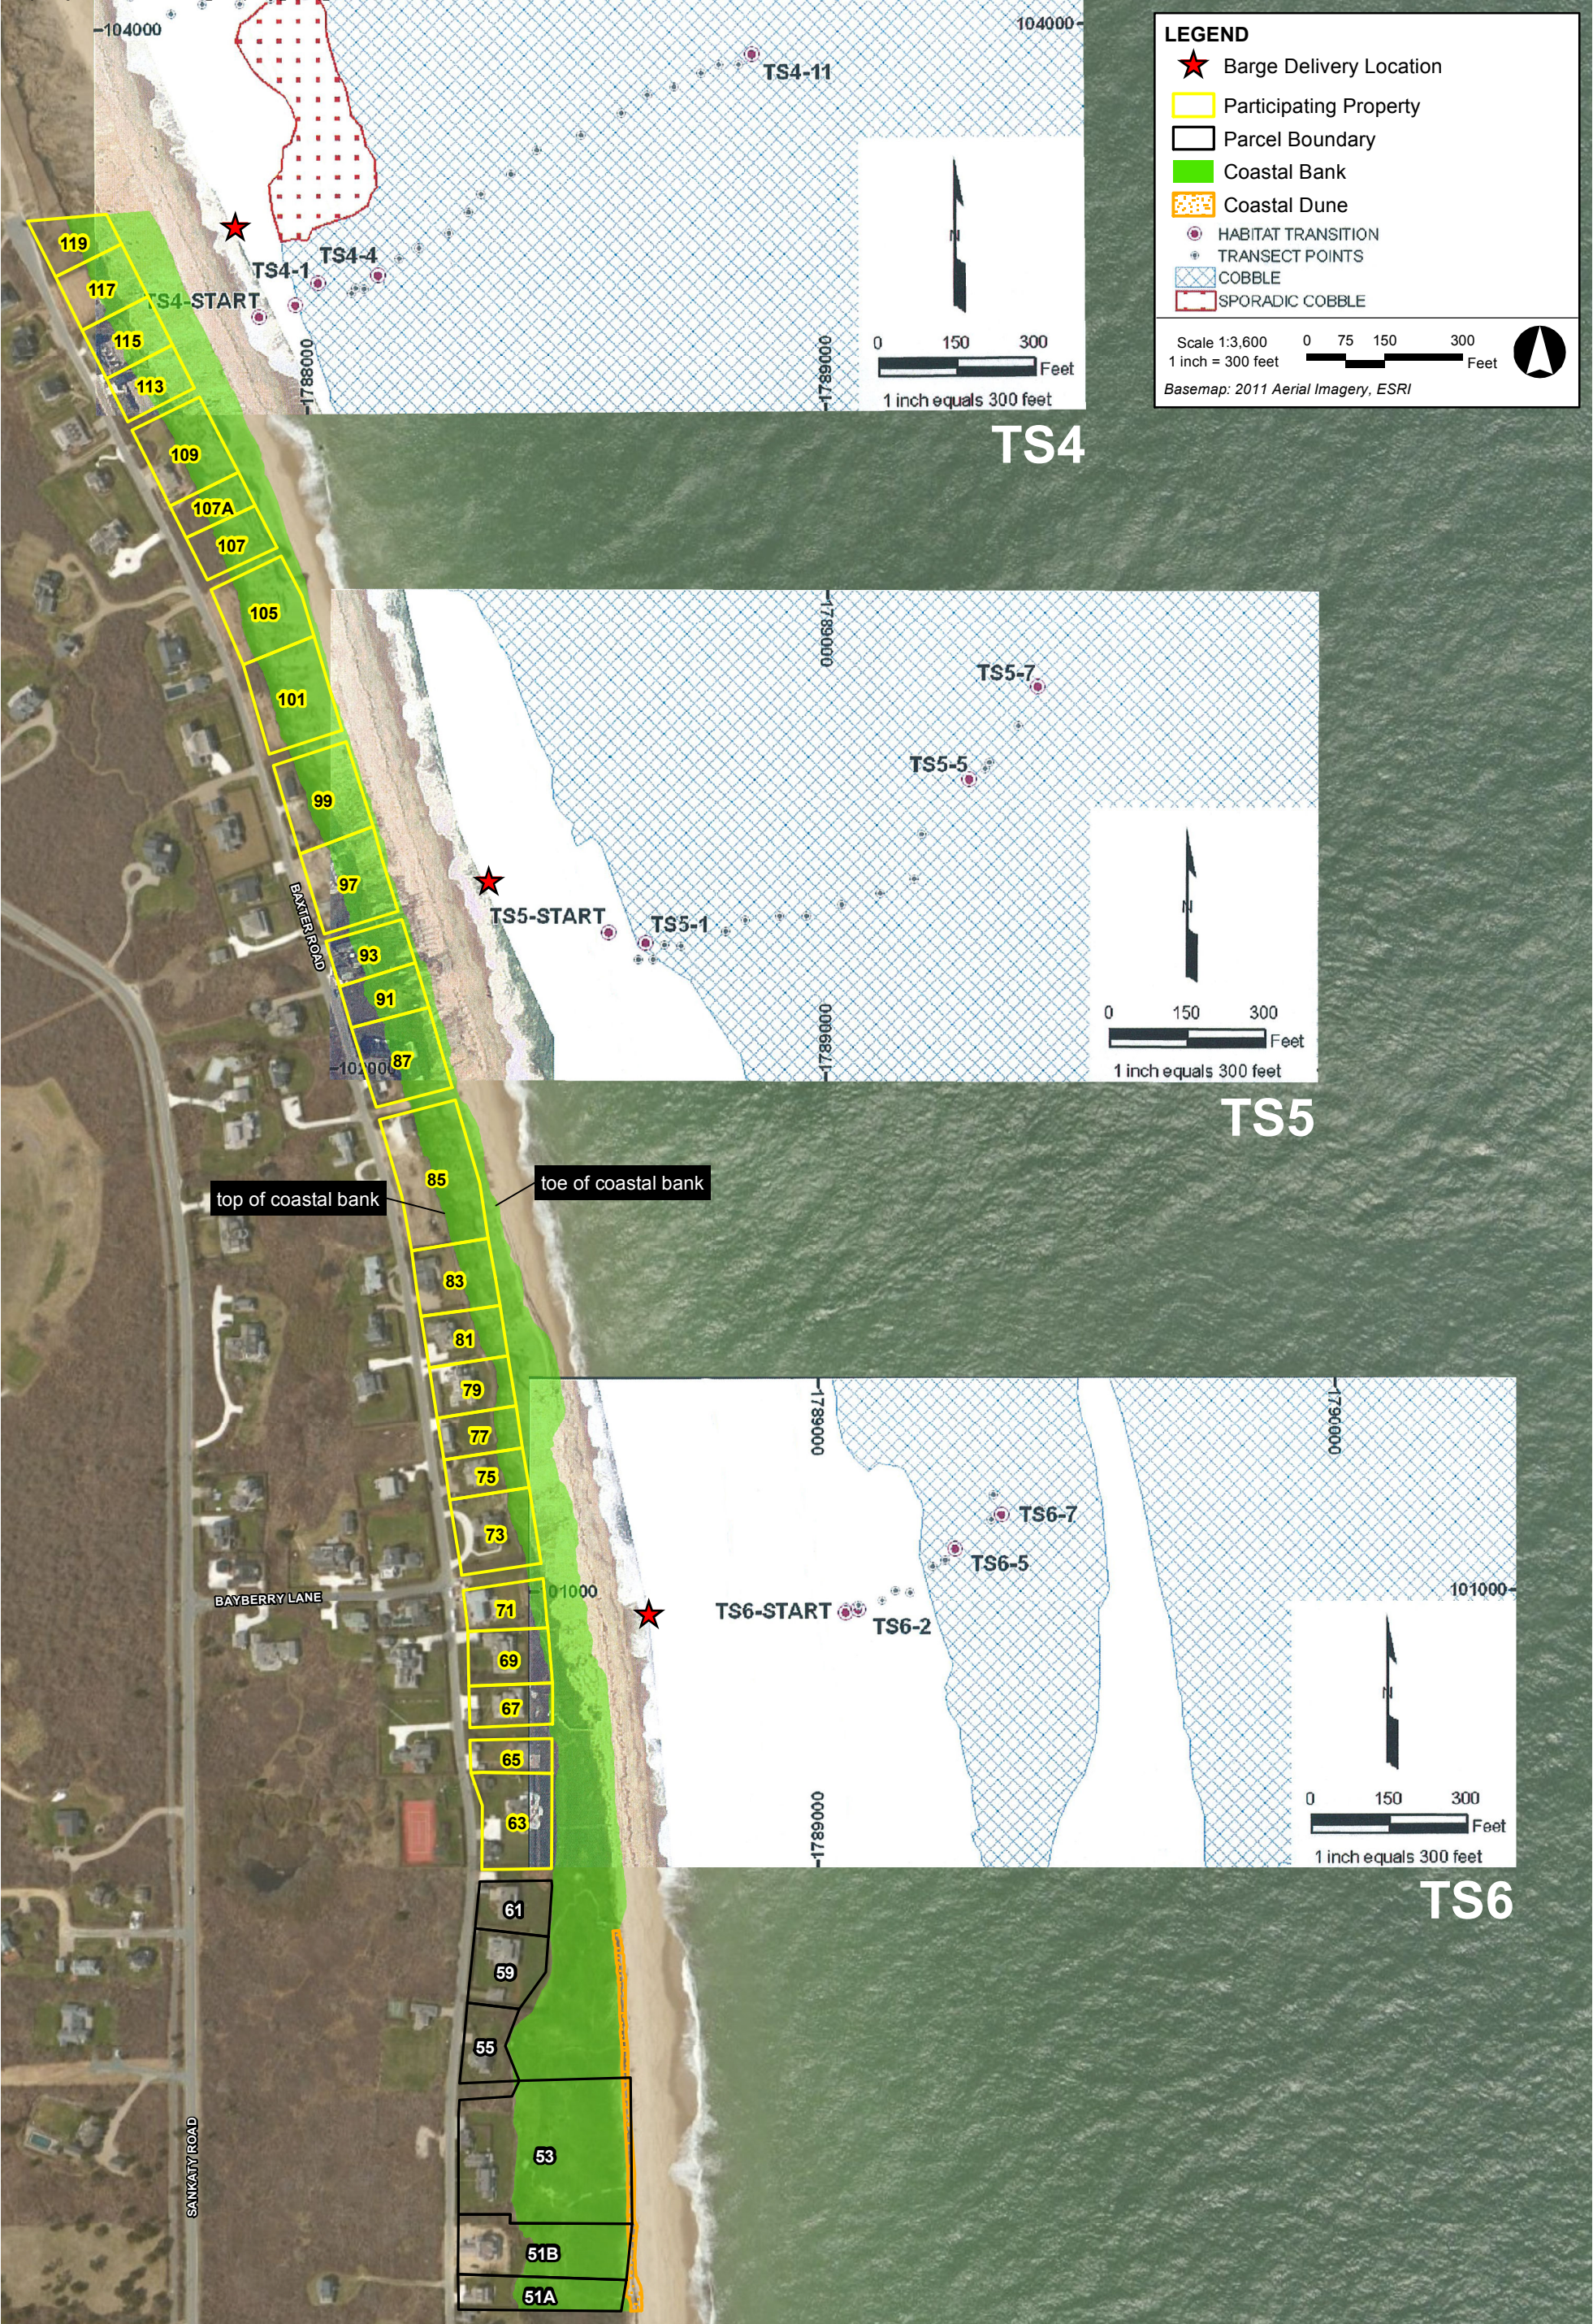
Figure 1
Barge Delivery Locations and Benthic Habitats

Figure 1 shows the location of potential barge landings. The barge landings are in the nearshore sandy sediment/benthic zone along the Sconset Beach, which is a very dynamic zone and is not a productive habitat as is the case of the offshore cobble habitat zones.

This figure also includes "Viewport Locations" labeled TS4, TS5 and TS6 which were prepared by Coastal Planning & Engineering (CPE) as part of the benthic community investigations for the proposed Sconset Beach Nourishment Project (see attached report). These "Viewport Locations" represent a combination of (1) high resolution side scan sonar (SSS) investigation of the seafloor to map benthic habitat (including cobble bottom) areas and (2) underwater nearshore transects surveyed via a marine biologist using scuba and underwater videography to record benthic habitats as well as fish species observed. Benthic habitats were grouped into three classifications: sand, sporadic cobble and cobble. The three transects in the revetment project area (TS4, TS5, TS6) have a sand benthic habitat nearest the beach with either sporadic cobble (as in TS4) or cobble habitat progressively seaward. Sand habitat is generally a very dynamic zone with few benthic organisms present. It was determined that cobble habitat located farther offshore may serve as a nursery for juvenile black seabass or other fish species.

Potential barge landing locations have been identified along the beach and in the sand habitat zone. None of the potential barge landing locations are located within cobble habitat and the beaching of the pier barge would not impact cobble habitat or other sensitive habitat areas. Since this sand zone is very dynamic with few benthic species present, potential impacts to benthic habitats by landing a barge along the beach is determined to be negligible.

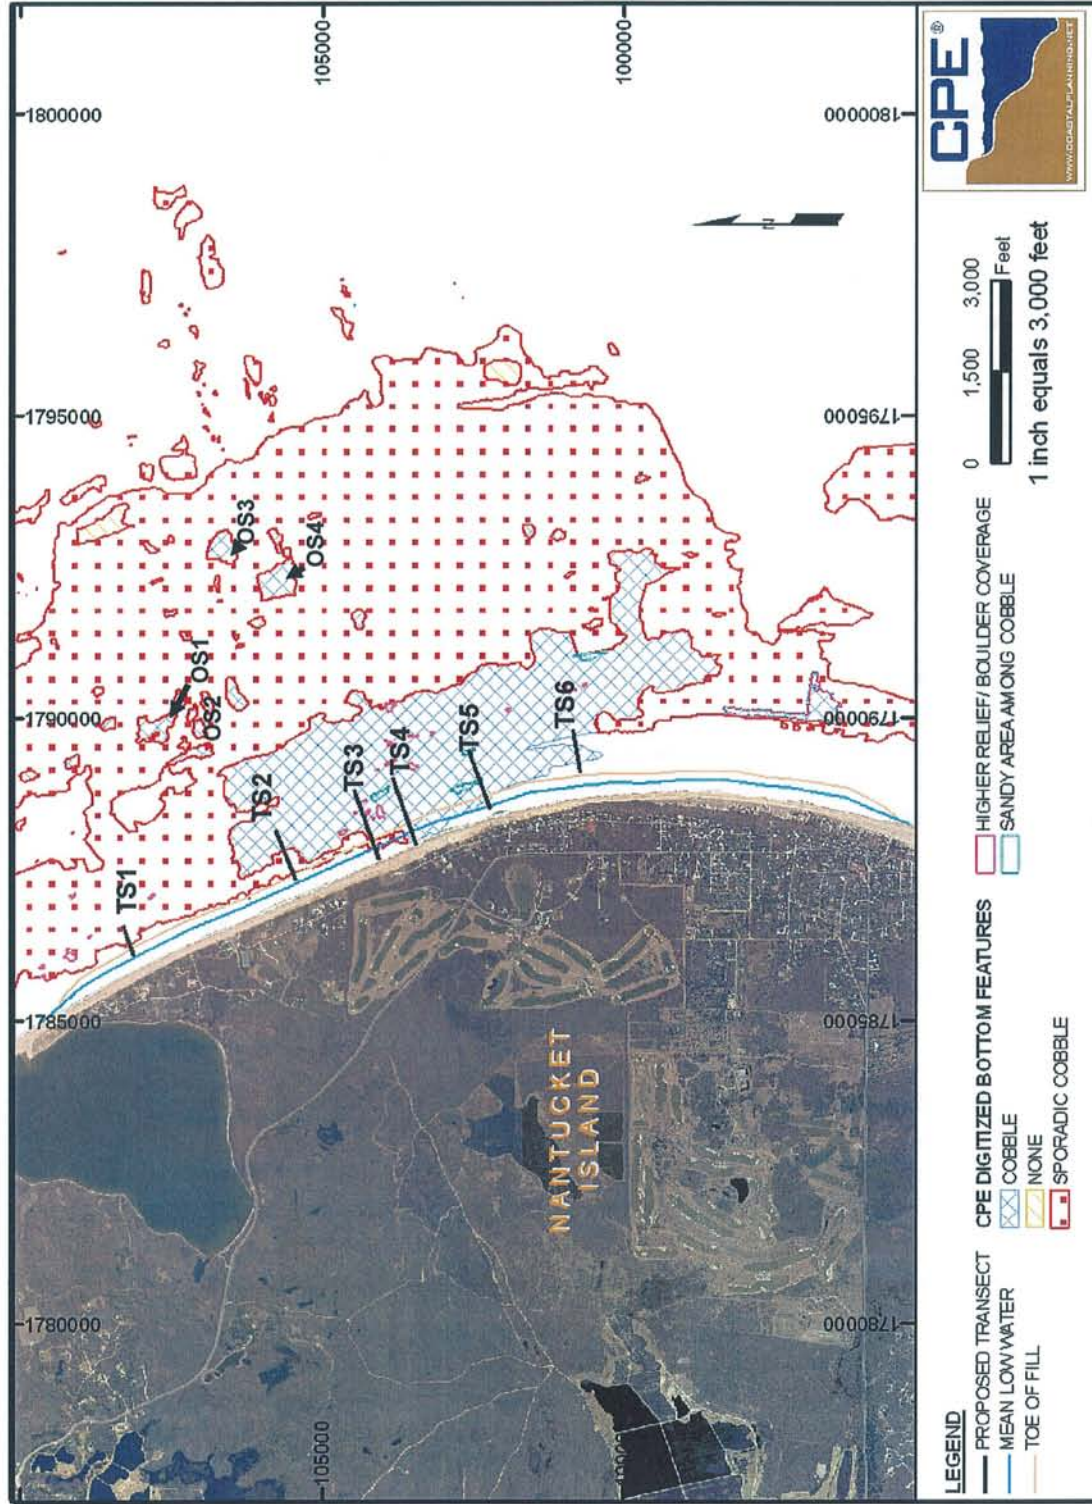
Figure 2. Proposed Location of Benthic Transects.

Nearshore transects were established perpendicular to the shoreline in order to intersect the change in habitat types oriented parallel to the coastline. Marine biologists worked in currents up to 1.5 knots or greater, which often influenced the transect line orientation at an angle slightly to the north or south, depending on the ebb or flood tide (See Figure 3). In general, the natural progression observed by marine biologists along each transect from onshore to offshore was: sand; sporadic small (<10% cover; <30 cm/12 in) cobble; sporadic (10-20% cover) cobble mixed with occasional large boulders (90 cm/36 in to 150 cm/60 in); moderate cover (20-40%) of medium-sized (30 cm/12 in to 90 cm/36 in) cobble with occasional large boulders; ending offshore with a higher percent cover (>40%) of medium-sized cobble with occasional large boulders. This transition, however, is a generalization of the overall area as some differences between transects were observed.

Transect 1 (TS1) differed from the other transects in that it was primarily sand with some small, sporadic cobble documented toward the offshore end. Transects 2 (TS2) and 3 (TS3) exhibited the typical transition from sand at the onshore end of the transects, to sporadic cobble, to denser cobble with large intermittent boulders occurring at the offshore end of the transects. Transects 4 (TS4) and 5 (TS5) had smaller cobble present than that found along other transects (no cobble observed over 16 inches).

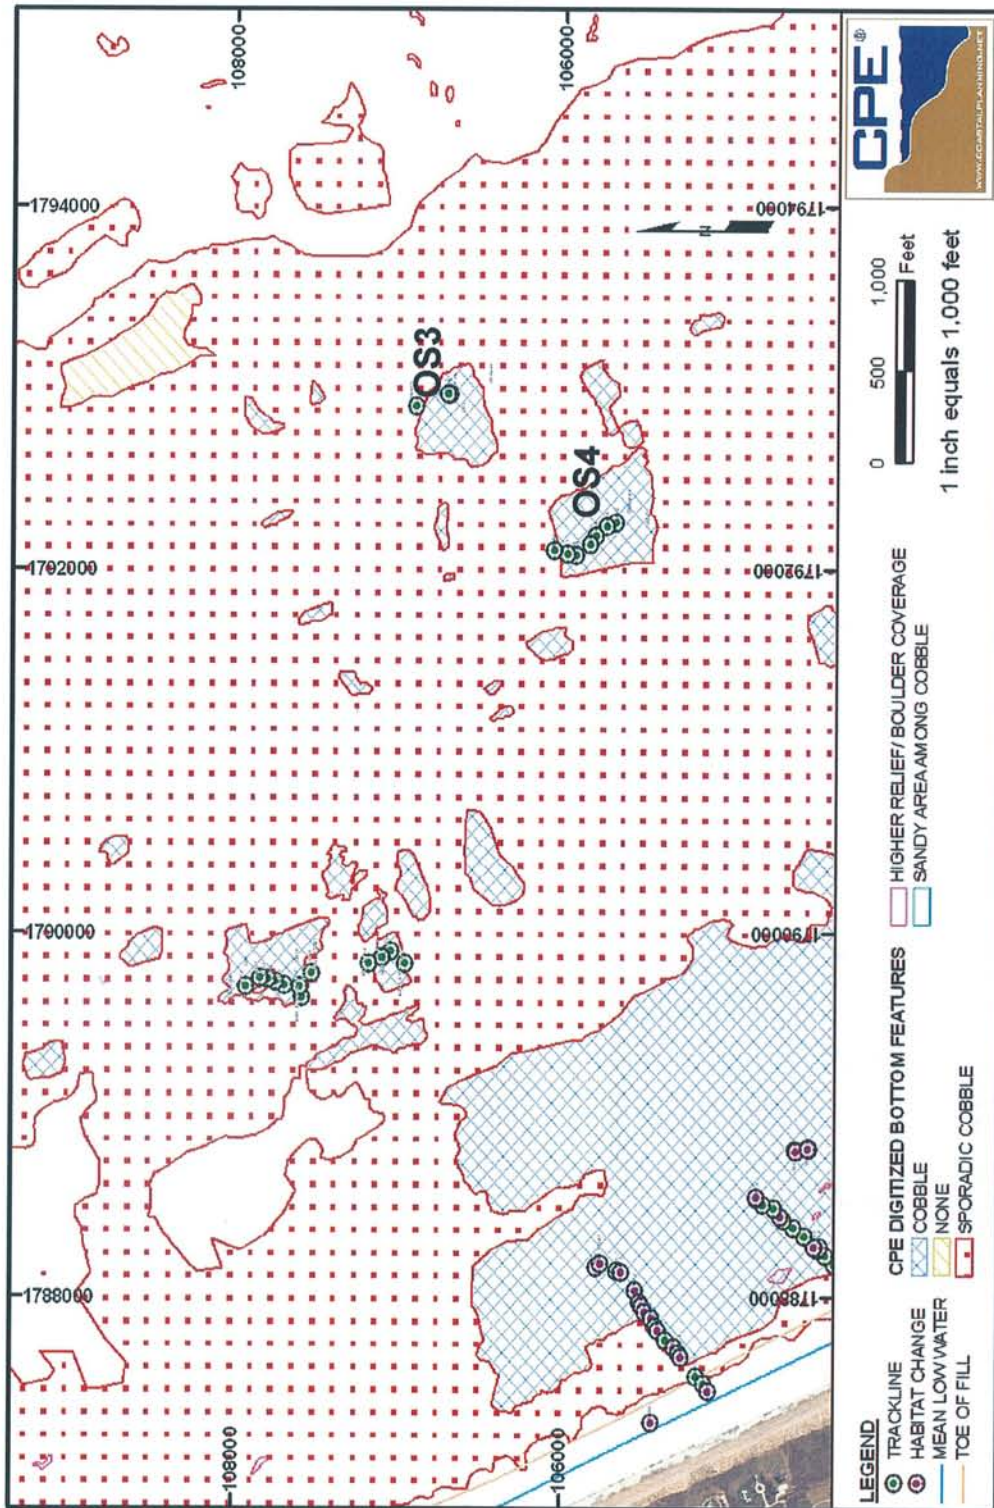
Figure 5. GPS locations of video documentation transects at the offshore sites.

Offshore sites were assessed in the same manner as the nearshore transects. However, the orientation of video lines across these sites was not pre-determined as with the nearshore transects (shore-perpendicular). Due to the extreme current (1.5 knots or greater) at these sites during the time of assessment, divers drifted with the current over the site while recording the habitat using underwater video (See Figure 5). Determining onshore to offshore transitions was not the goal of assessing these sites; rather, divers groundtruthed these areas based on side-scan sonar results and assessed habitat type and quality. Biologists found that Offshore Sites 1 and 2 (OS1 and OS2) differed slightly from Offshore Sites 3 and 4 (OS3 and OS4).

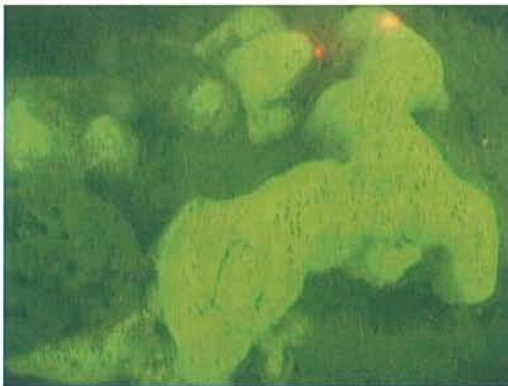
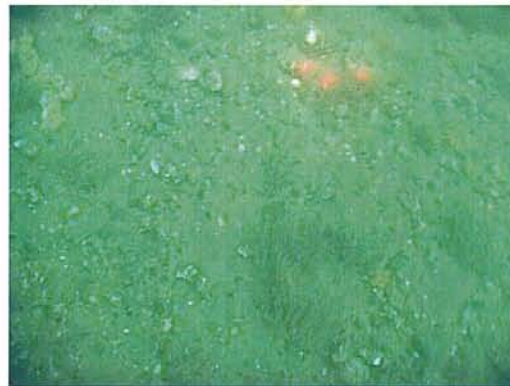
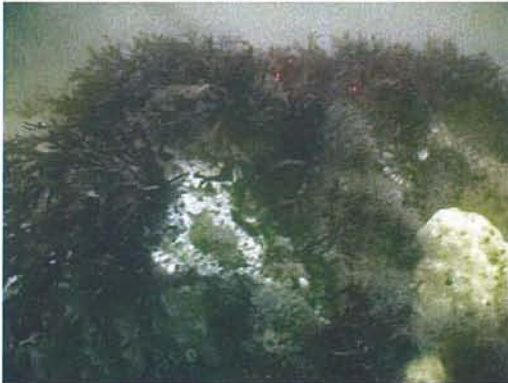
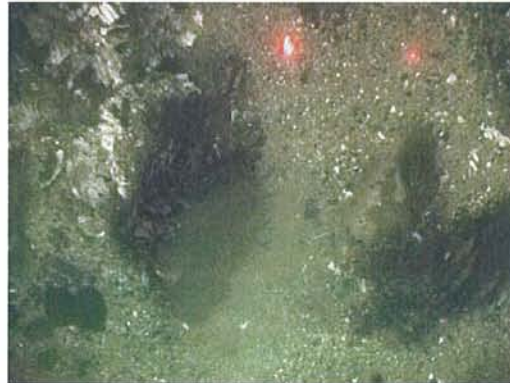
Figure 6. Representative photos of Offshore Sites 1, 2, 3 and 4. Red dots indicate video laser alignment system.

Sponge *Cliona celata* observed at OS1 and OS2

Gravel halo typical around OS1 and OS2

Macroalgae *Chondrus crispus* found at OS3 and OS4

Sand/gravel observed between cobble at OS3 and OS4

Offshore Sites 1 and 2 contained dense cobble (50% cover or greater) typically 30 to 90 centimeters (12-36 in) in diameter with intermittent large boulders up to two meters (7 ft) in diameter. Although the macroalgae *C. crispus* was observed on much of the cobble, a higher percent cover of the yellow sponge *C. celata* was noted at these sites when compared to the nearshore sites. Both of these sites were bordered by a perimeter of gravel and shell debris, although OS2 was less pronounced and ended abruptly in a steep sand bank. See Figure 6 for representative photos of the offshore sites.

The habitat found at Offshore Sites 3 and 4 was more similar to the nearshore transects than Offshore Sites 1 and 2 (See Figure 6). Cobble here was generally smaller than that found at OS1 and OS2 (15-45 cm/6-18 in) with occasional large boulders. Percent cover of *C. crispus* was also comparable to that on the nearshore transects, and *C. celata* was not as prevalent as at OS1 and OS2.

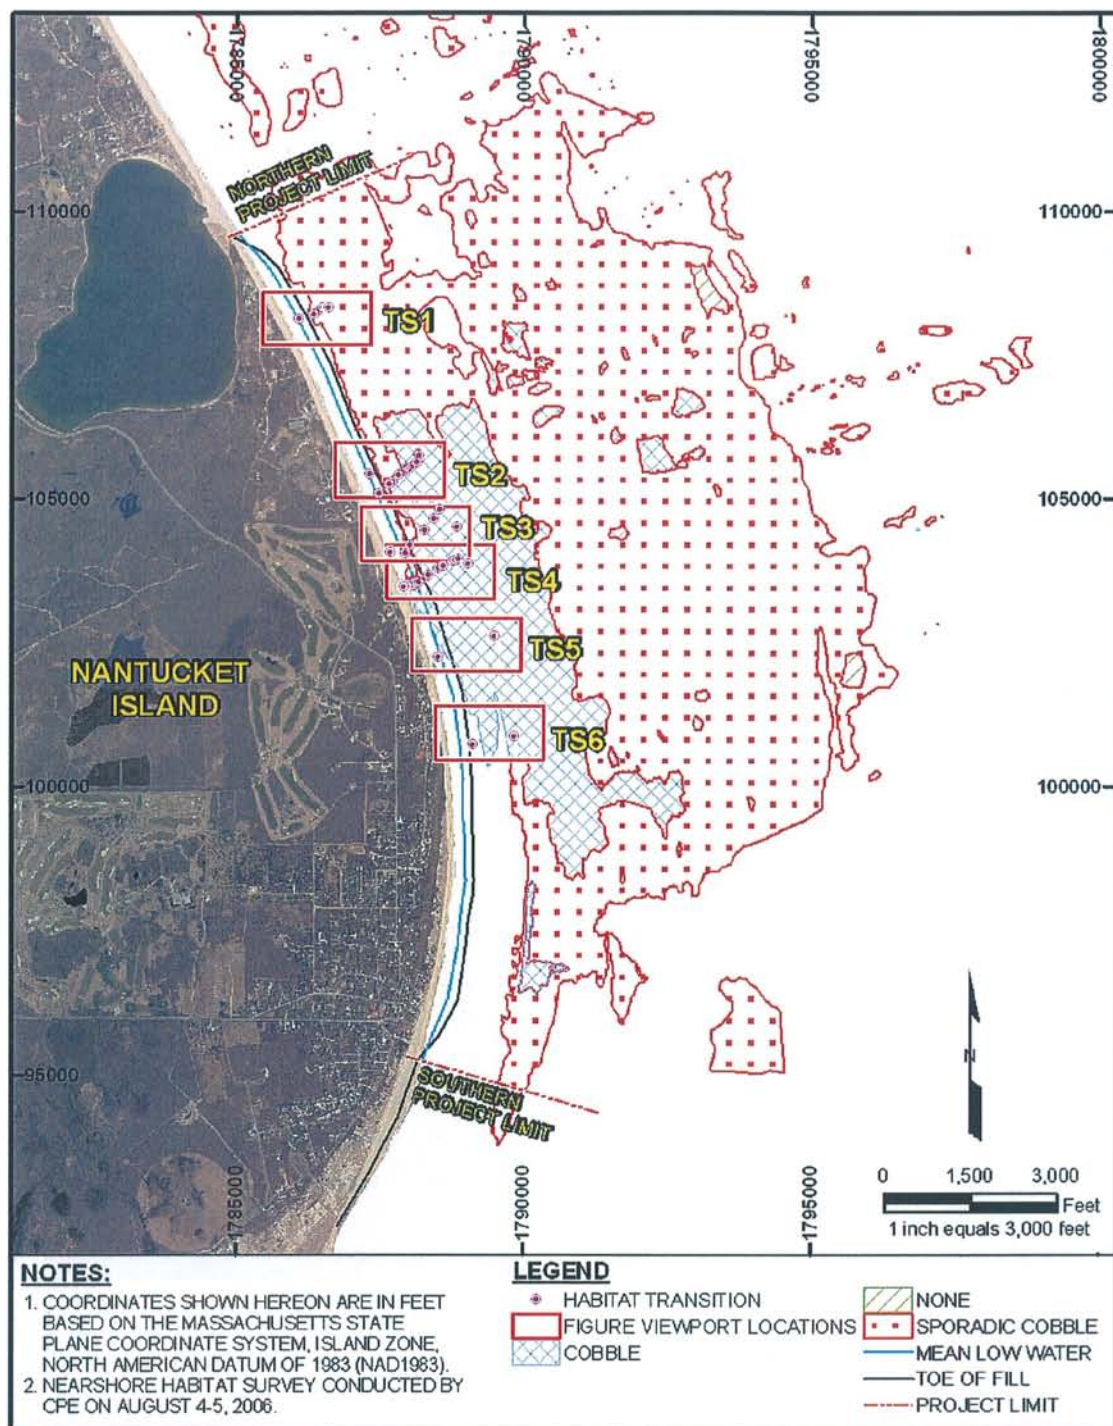
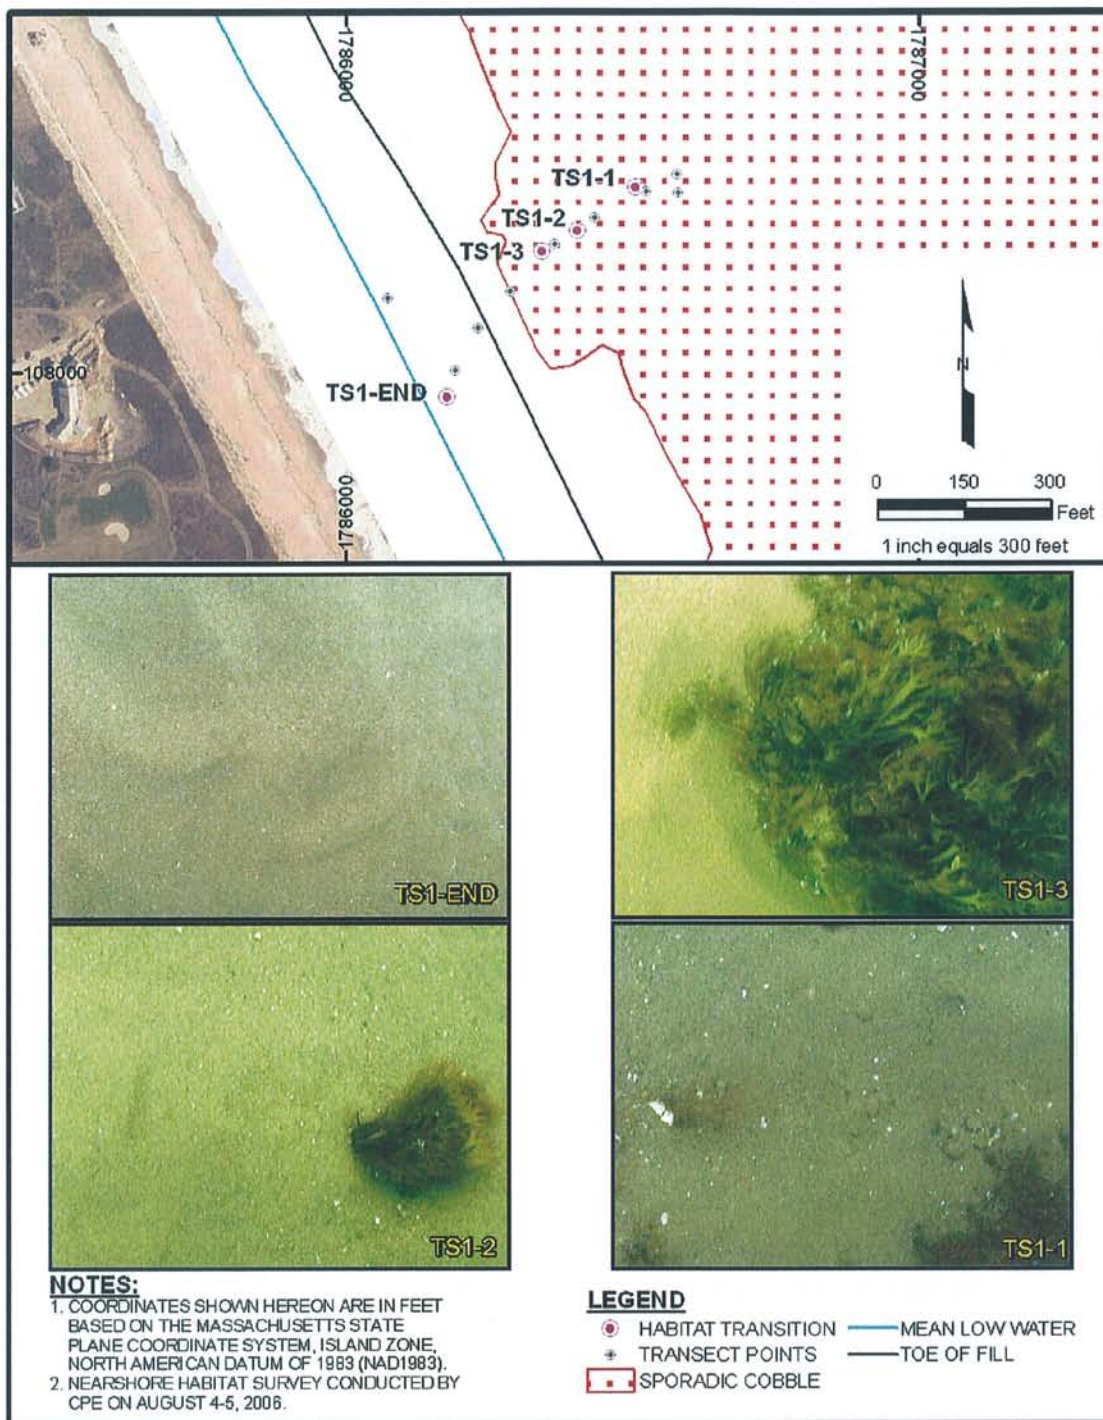
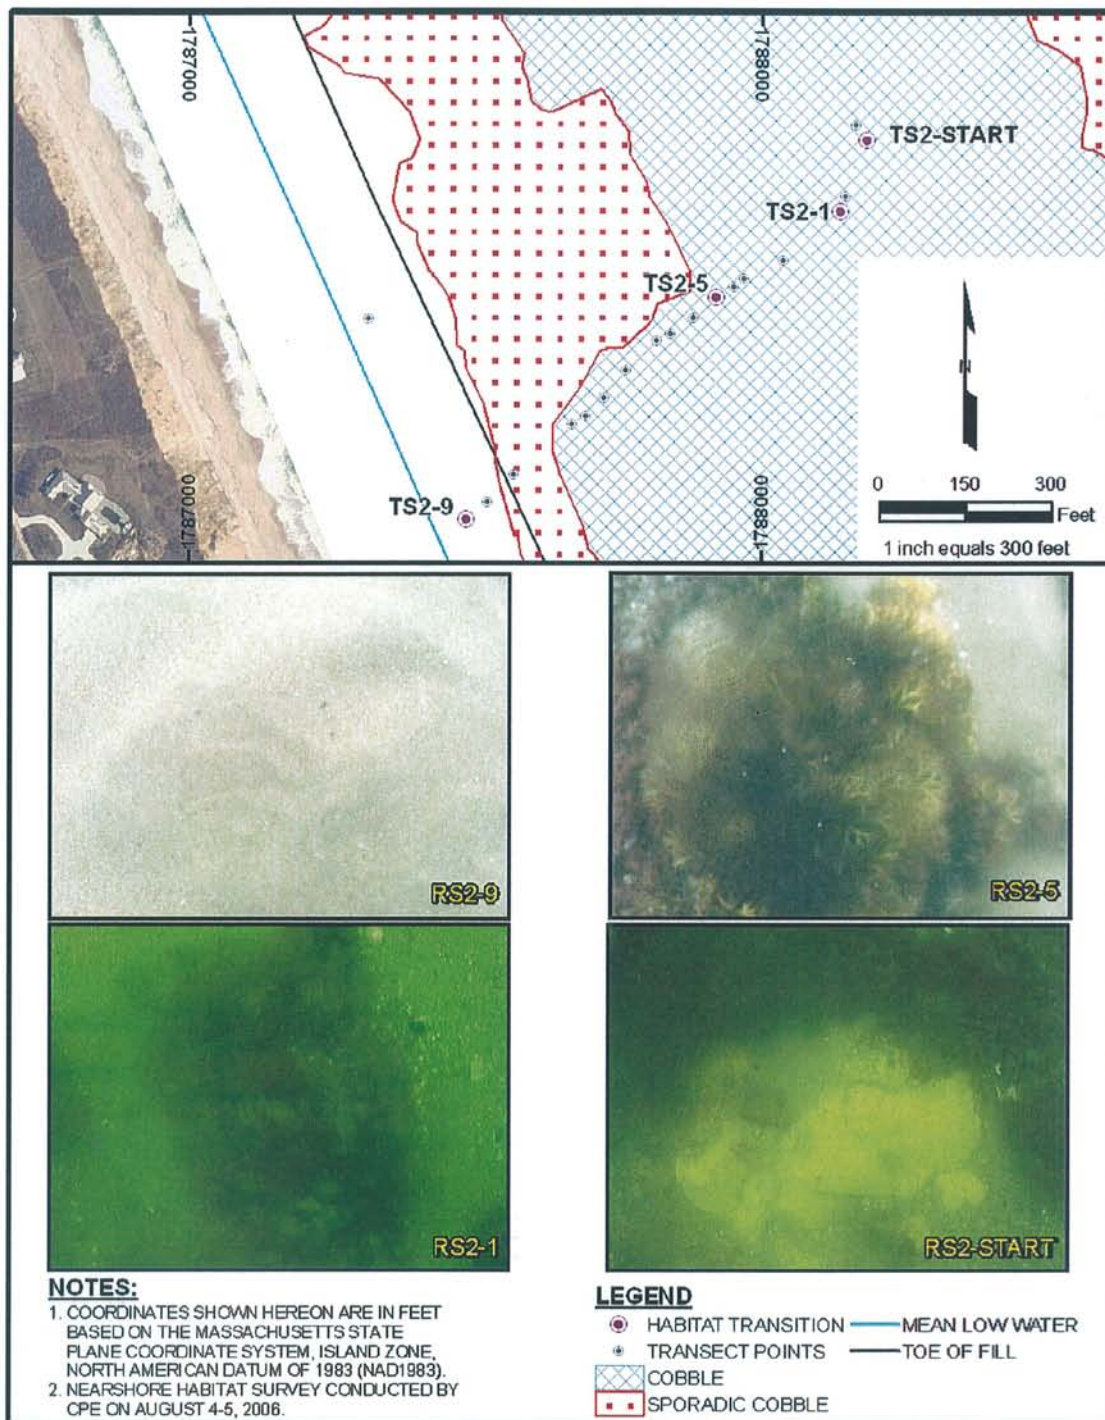
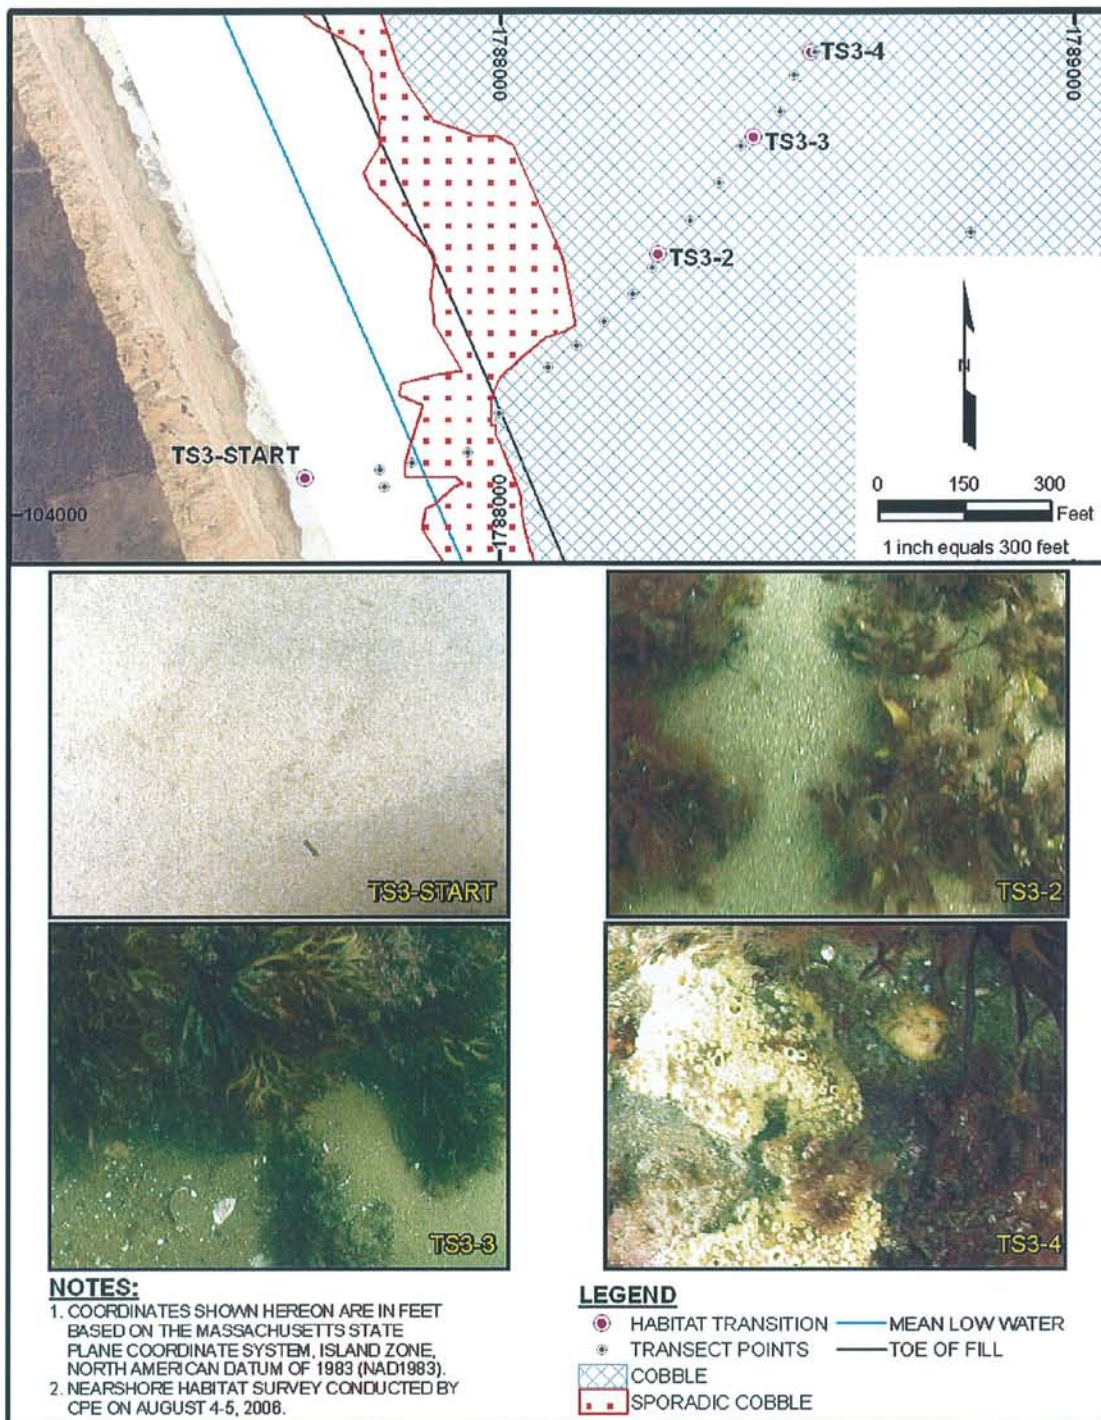
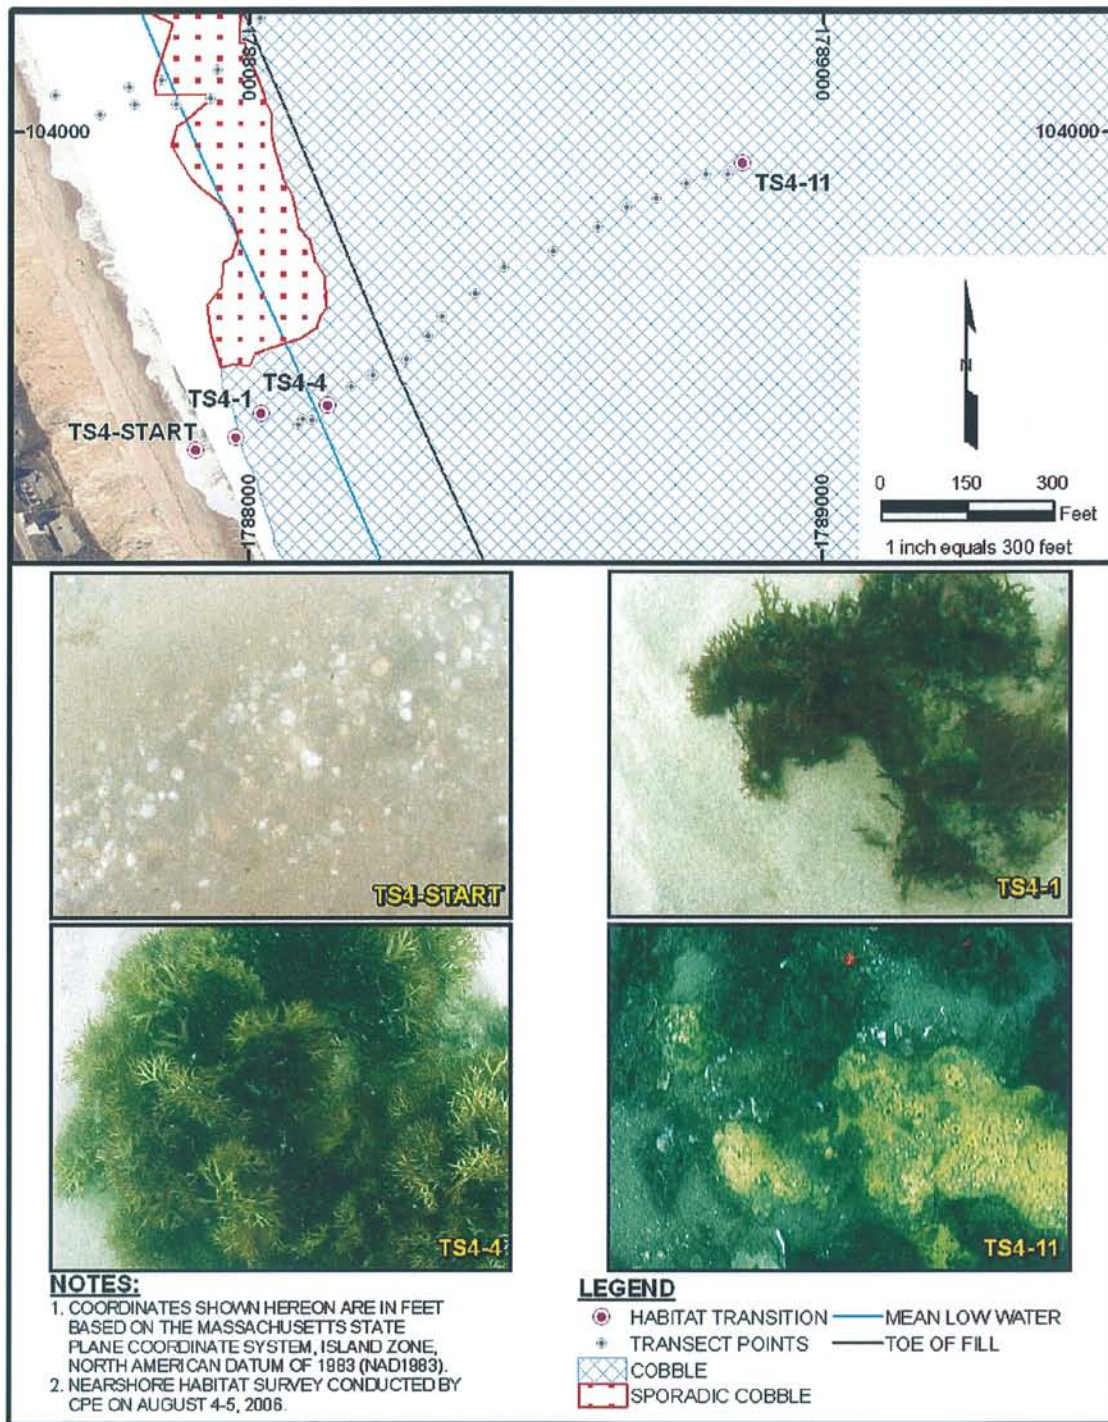
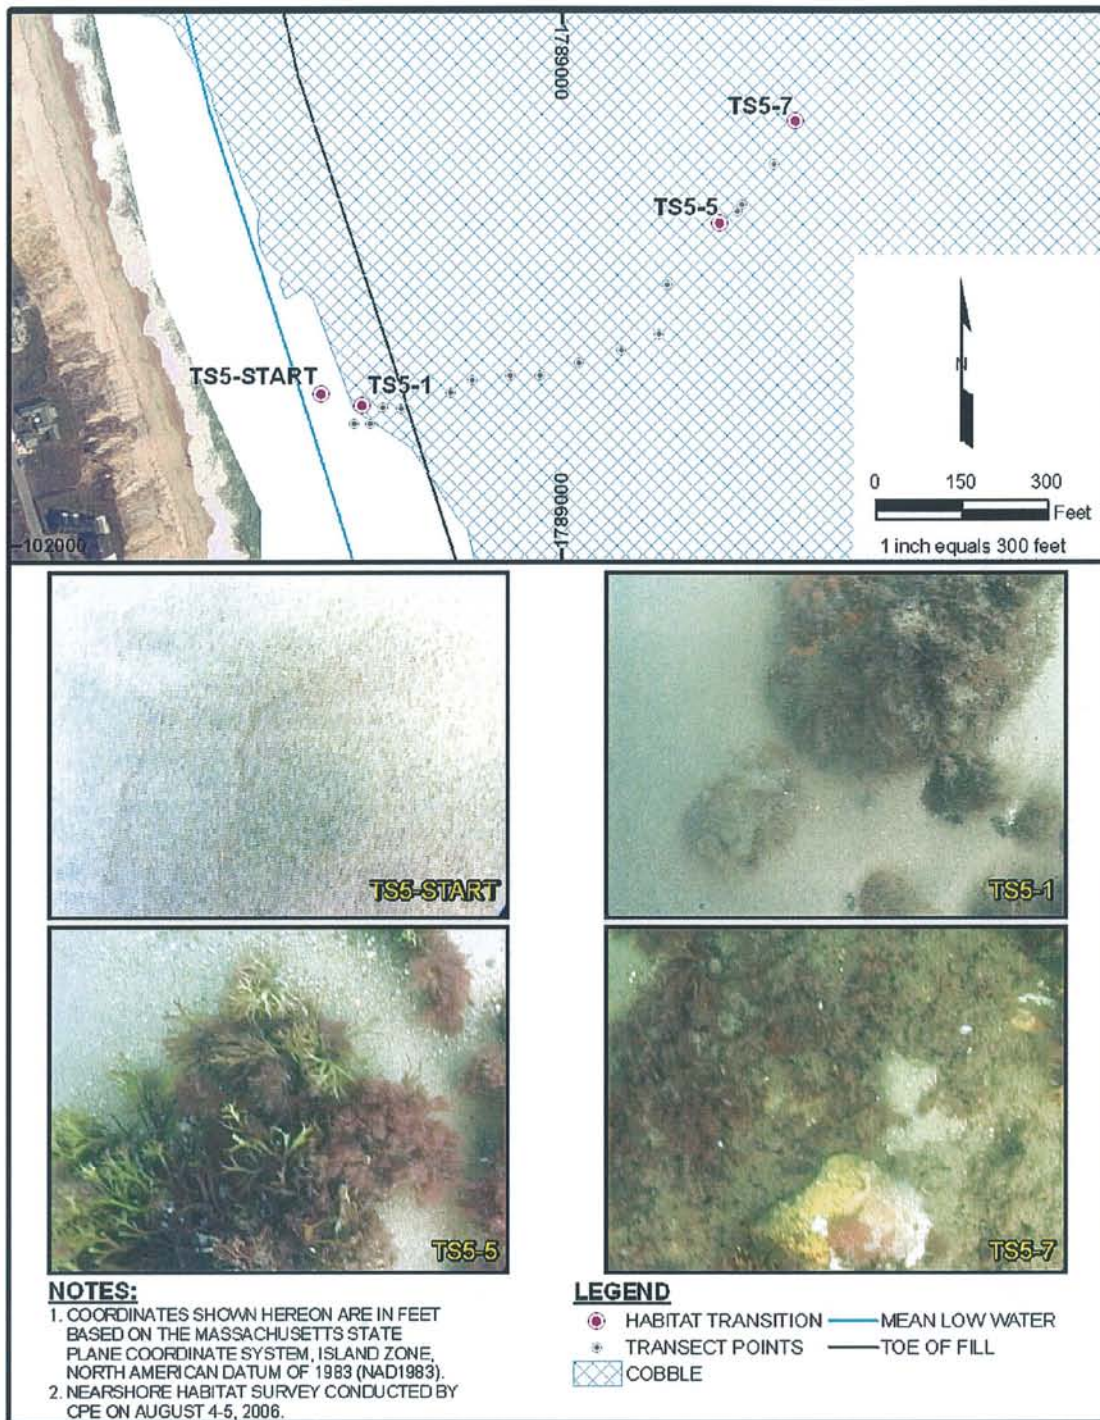
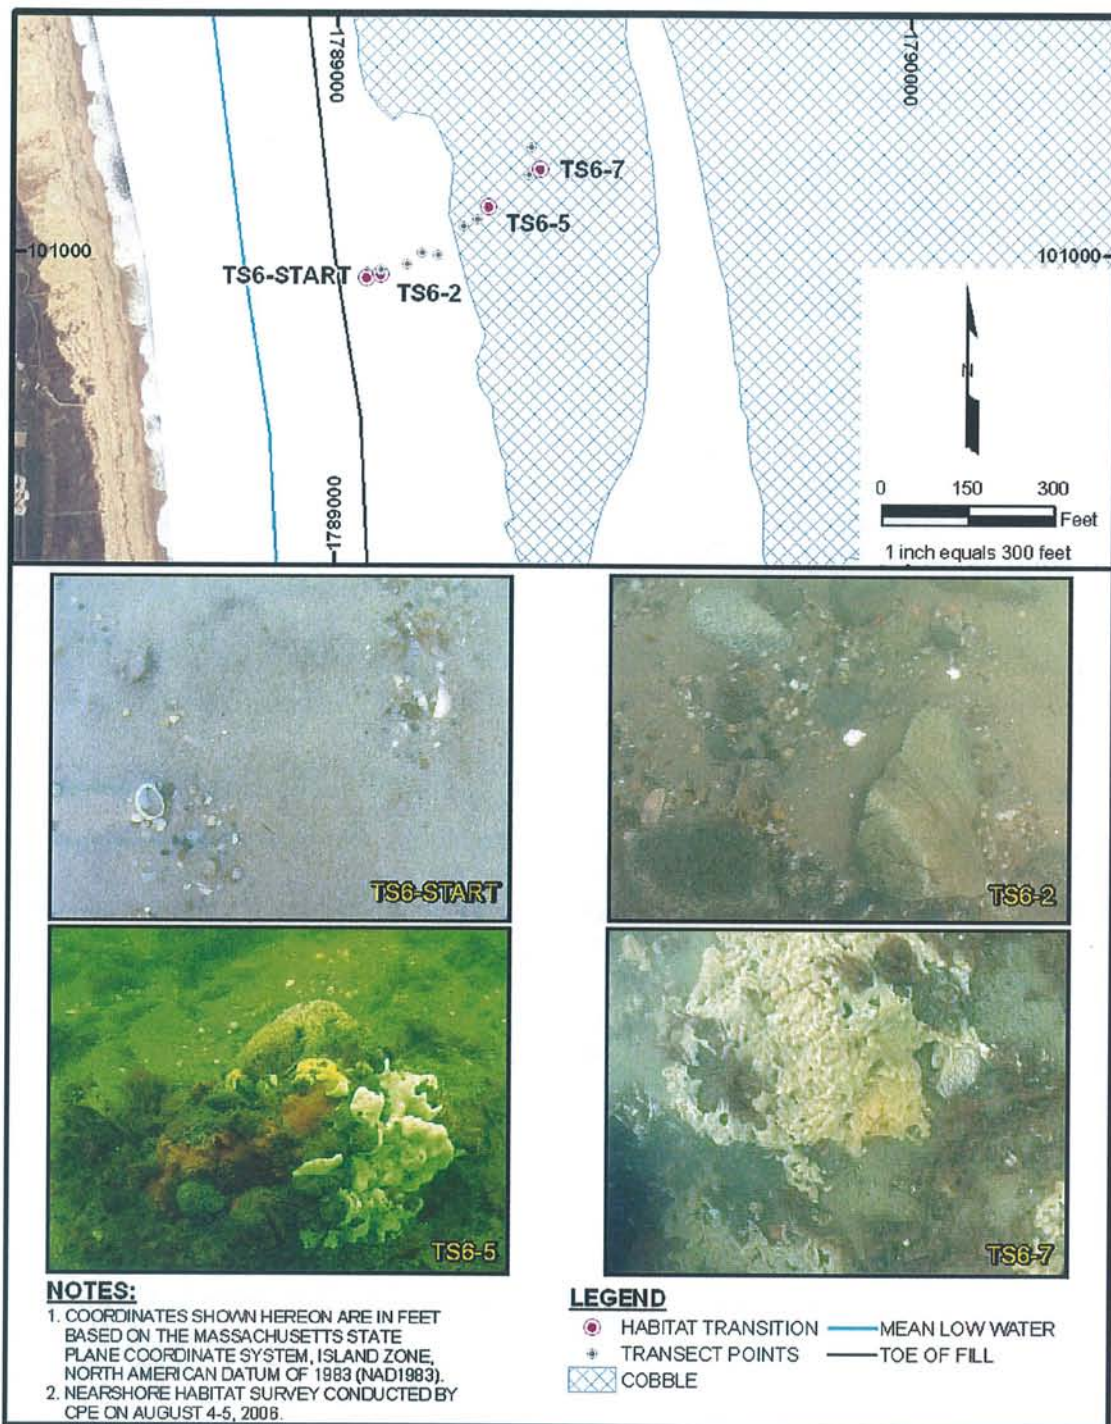
Figure 7a. Habitat transitions.

Figure 7b. Habitat transitions.

Figure 7c. Habitat transitions.

Figure 7d. Habitat transitions.

Figure 7e. Habitat transitions.

Figure 7f. Habitat transitions.

Figure 7g. Habitat transitions.

Table 1b. Size and percent cover of cobble per transect (TS4-TS6). Transitions are numbered in order from offshore (OS) to nearshore (NS) and correspond to transitions shown in Figure 7 (though sometimes in reverse order if the transect was run from nearshore to offshore)

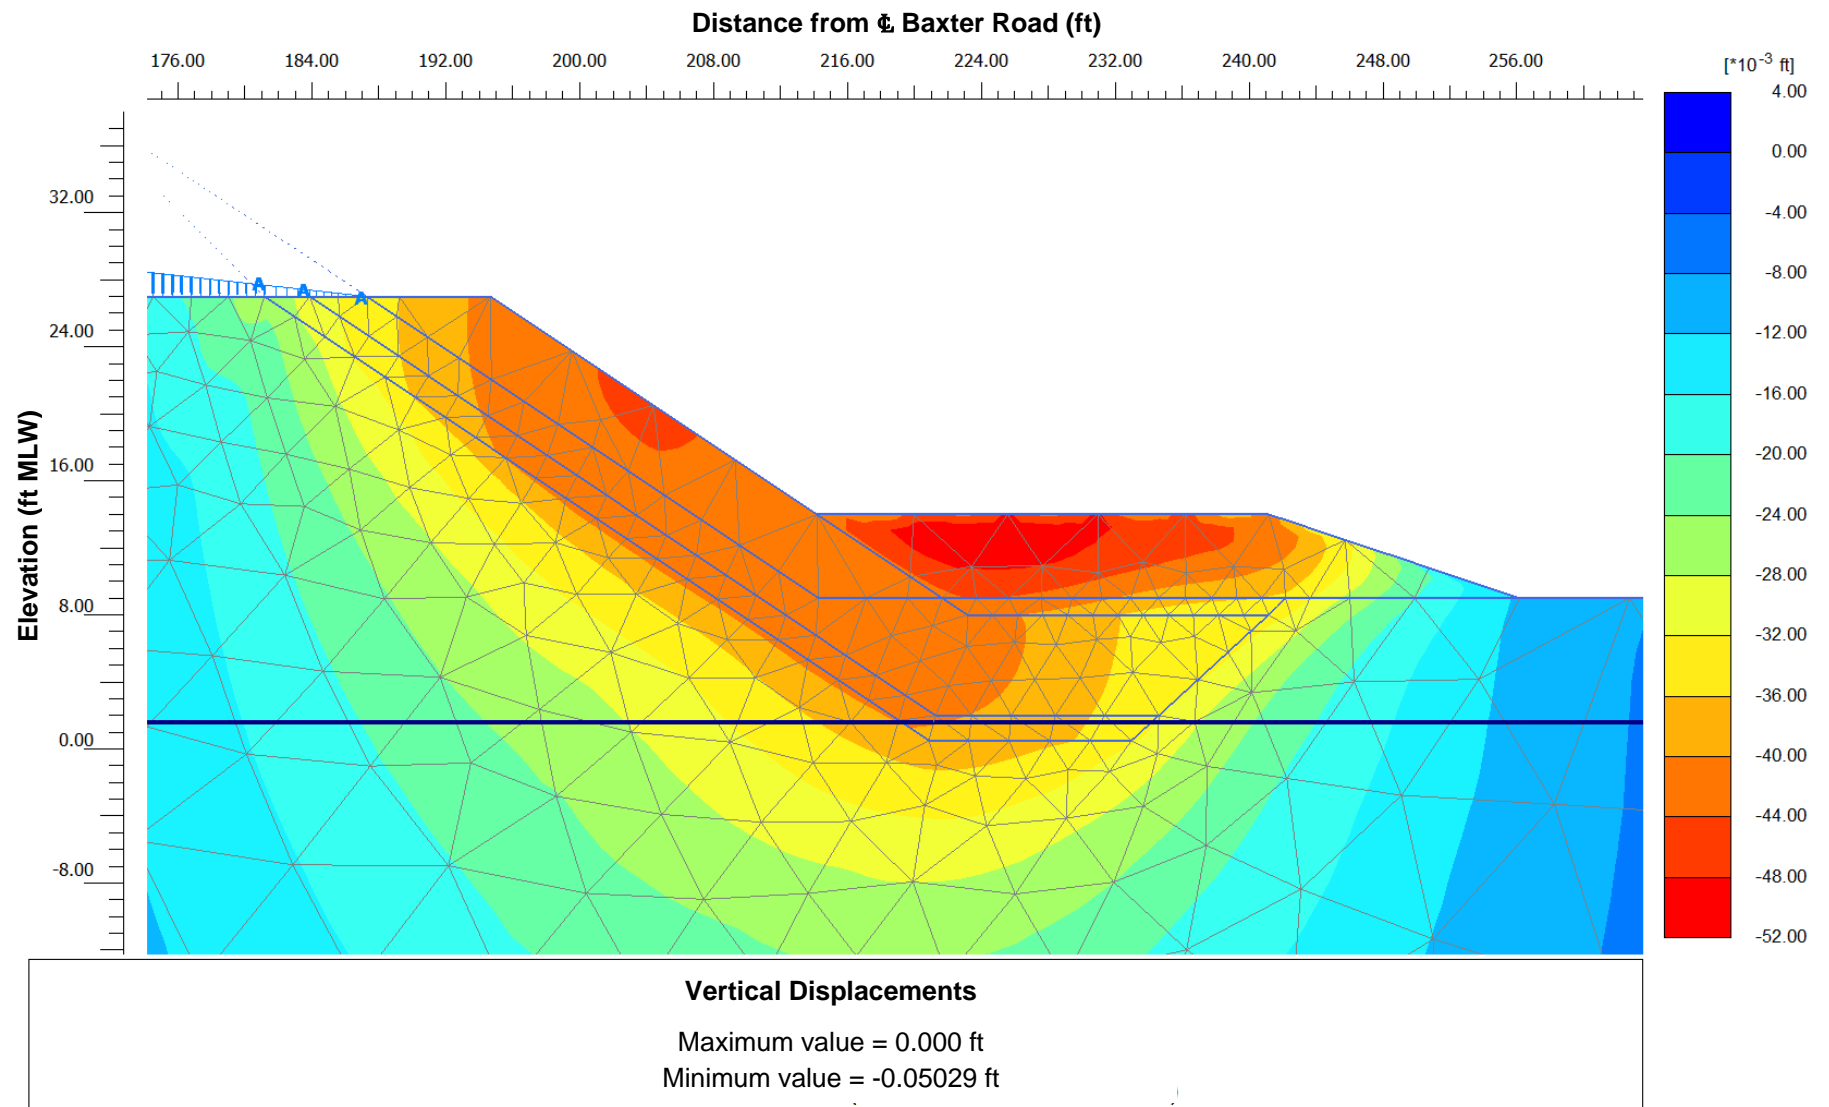
Figure 1. Plaxis results – Vertical settlements of proposed revetment with sacrificial berm at toe.

Two conditions of the proposed revetment were analyzed in Plaxis: (a) with a sacrificial sand berm at the toe (Figure 1); and (b) without the berm (Figure 2). The maximum potential vertical settlement for both conditions is only about 0.6 inch, which is negligible compared to the amount of sand removed and the revetment material placed and unlikely to affect the function of the proposed revetment. Note that more vertical settlements could be expected if weaker soils are actually found within the assumed extent of coastal beach sand.

“Two conditions of the proposed revetment were analyzed in Plaxis: (a) with a sacrificial sand berm at the toe (Figure 1); and (b) without the berm (Figure 2). **The maximum potential vertical settlement for both conditions is only about 0.6 inch, which is negligible compared to the amount of sand removed and the revetment material placed and unlikely to affect the function of the proposed revetment.** Note that more vertical settlements could be expected if weaker soils are actually found within the assumed extent of coastal beach sand.
